Retrofitting old display cases

David Thickett*, Bethan Stanley and Kevin Booth

English Heritage
1 Waterhouse Square
138 Holborn
London
UK
E-mail: david.thickett@english-heritage.org.uk
Website: www.english-heritage.org.uk

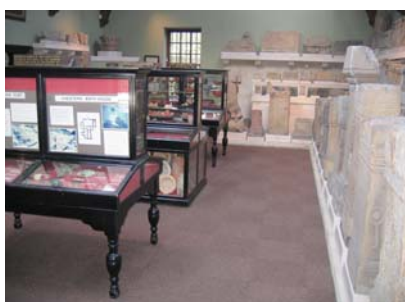
Figure 1. 1920s cases at Chesters

At Chesters Museum in Northumberland, the cases have been monitored for a number of years, and data indicates the conditions are less than ideal for the archaeological small finds they contain (Figure 1). Despite these shortcomings, both staff and Trustees feel it is important to keep the historic cases as they add to the air of a 'Victorian Museum' and therefore the philosophy behind the acquisition and display of the collection.

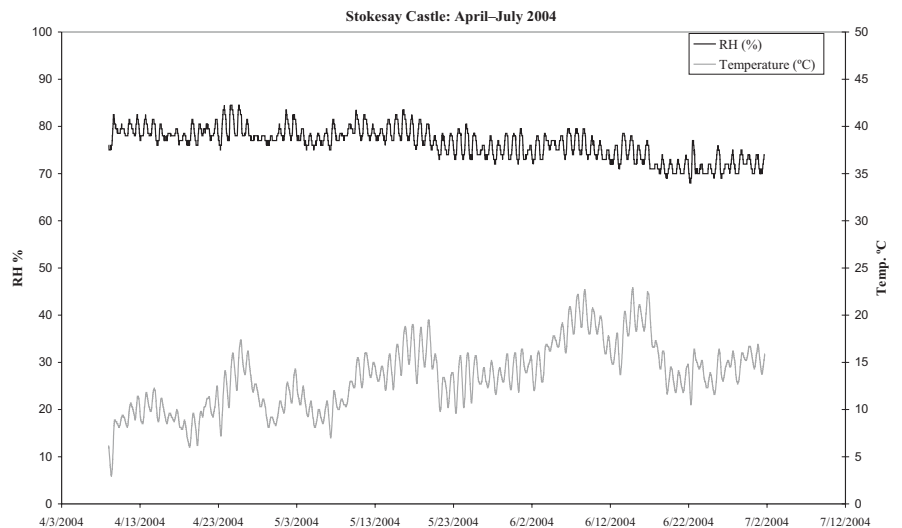
Monitoring of the environment (Hanwell Humbug II dataloggers) indicated that the case experienced very high relative humidity (RH) levels because of its location and deterioration was observed. The hinged case construction had a lot of air leakage through the joint between the lid and the case, with a slight warping of the wood, opening up the other lid joints. It was decided to try to reduce the RH by adding Prosorb to buffer the case and to improve the sealing of the case. Self-adhesive compression seals were added to the door edges. A wooden bar was also manufactured and fitted into the case below the back edge to allow the door to close onto the seal and ensure a tight fit. Moistop 622 was applied to the interior of the wooden case and new top bar with 3M 425 aluminium tape. This was to prevent the emissions of ethanoic acid, which has a strong influence on the deterioration of lead, as well as a significant accelerating effect on the deterioration reactions of archaeological iron.

Figure 2 shows a comparison of the three-month periods before and after the refit, but before the Prosorb has been added. The case is better sealed but the Moistop has blocked the buffering effect of the wood resulting in short term, larger RH variations. The addition of Prosorb to the case reduced the overall RH and fluctuations, providing a more suitable, stable environment.

Figure 2a. Historic case

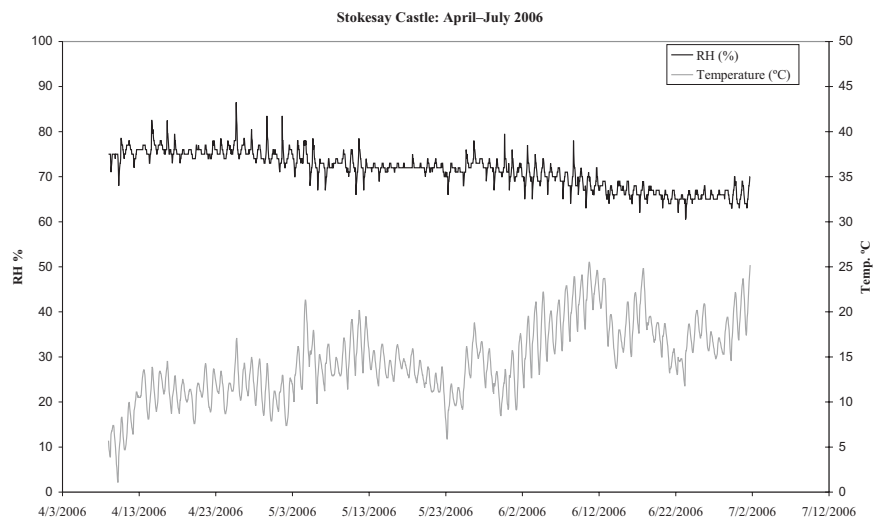
Figure 2b. After refit

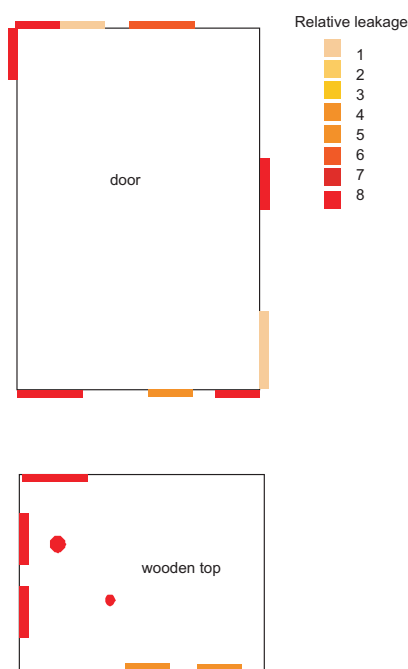
Figure 3. Leakage from case

The fabric was replaced in 2006 and attempts were then made to further seal the showcases to reduce tarnish rate. The cases had large holes in their tops for the fibre-optic lighting cables, which were sealed with 3M 425 tape and Dow Corning silicone sealant. Silicone compression seals were applied to all four edges of each case door. A leak detector was used to confirm complete sealing for the doors and fibre-optics and to determine any further gaps in the case structure, see Figure 3. Additional leakage was detected from cracks in the top of the case and these were sealed with silicone. Air exchange rates and silver tarnish rates were measured before and after this process. An average case decreased its air exchange rate from 5.75 to 0.23 day^{-1} and the silver tarnish rate was reduced by a factor of almost four. These results are in accord with reductions in tarnish rate inside showcases recorded in other properties (Thickett *et al.* 2005).

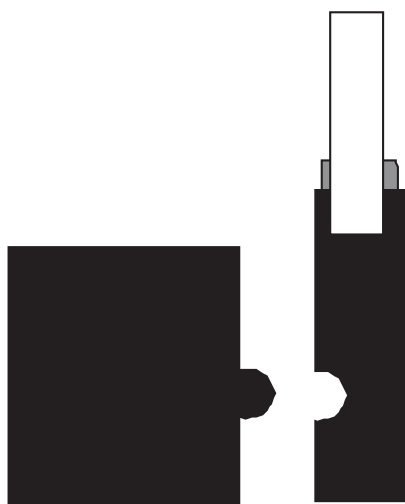
The original 19th century case doors had a worked profile, possibly to minimise dust ingress, see Figure 4. It was thought this may be effective at reducing water vapour movement through infiltration around the door as well and this was compared to modern compression seals. The door of one original case was left unaltered and its performance compared with a recent case of the same size and similar original air exchange rate before sealing. The air exchange rates and observed RHs within the two cases were very similar indicating that the old joinery techniques provided an efficient seal, comparable with modern compression seals.

Figure 4. 1840s case door section

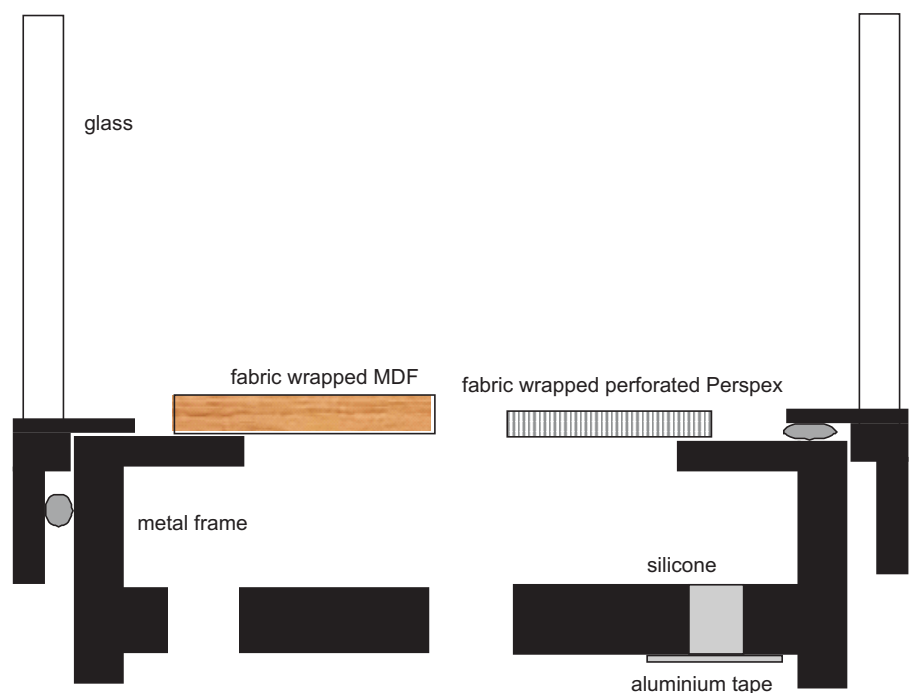
The cases were examined and a number of modifications made to improve their performance. New seals were introduced between the glass and tops of the frames to ensure compression, as original extruded silicone seals between the glass and the side of the frames were not effective, see Figure 5. Each case was found to have four 11 mm diameter holes in the metal frames (showcases are often made from standard templates incorporating a large number of holes for potential fitting of lighting, locks, etc). The holes were blocked with 3M 425 tape and silicone sealant. One case demonstrated a drop in exchange rates from 7.91 to 0.21 day⁻¹ after this was

Figure 5. Case cross-sections Down House; left before refit, right after refit

undertaken. Lastly it was found that the close fitting of the MDF baseboards was preventing air exchange between the silica gel facilities and display volume. MDF baseboards were replaced with Perspex ones, with 20 mm holes covering 30% of their surface to allow good air movement through them. Each case had 500 g of ProSORB granules preconditioned to 50% RH, added to the silica gel facility, giving a loading in excess of 65 kg/m³. The cases are now able to retain an RH above 40% throughout the winter and spring heating period, despite the room RH dropping to 20% for long periods.

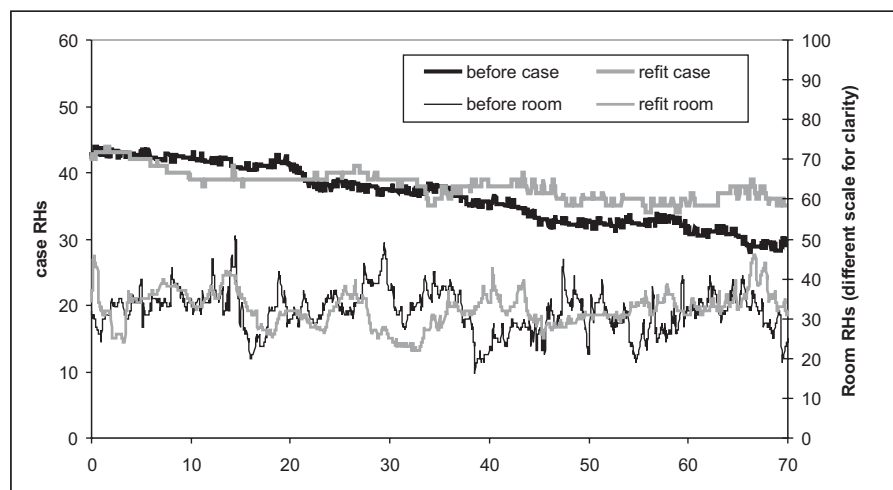
Charles Darwin lived at Down House with his family between 1842 and 1882 and formulated his theory of natural selection there. The upper floor of the house was developed in 1995 to present a museum with artefacts from Darwin's voyages and natural history specimens and new cases were installed. Environmental monitoring indicated that the humidity levels within the showcases were too low during the winter and spring period due to the comfort heating.

Figure 6. RH in case and room before and after refit

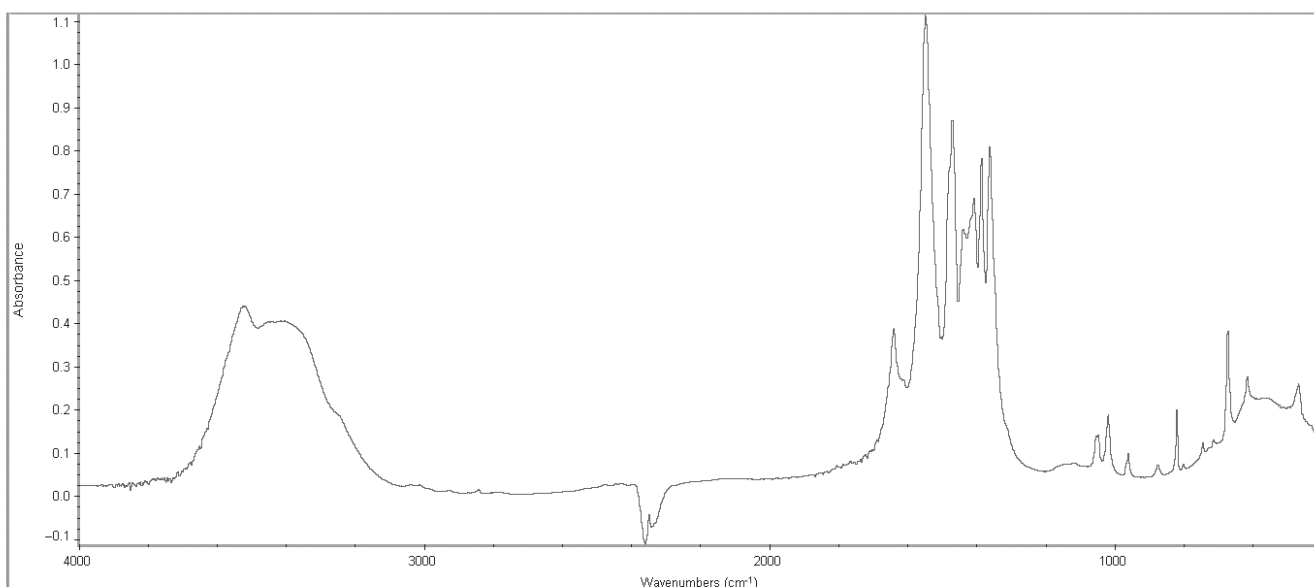
Efflorescences were observed on soft white *Mytilus* shells at Down House. They were analysed as calcium chloride nitrate ethanoate by infra-red spectroscopy, matching a standard from the Infra-Red and Raman User Group database (IRUG). Three potential sources of ethanoic acid were suspected.

Figure 7. FTIR spectra of corrosion on shell

further. The MDF had a clear applied lacquer. This was analysed as Dacrylate 903–1 with infra-red spectroscopy. This lacquer has commonly been used in the UK since 1995 and although it blocks emissions of methanal, it has almost no effect on ethanoic acid emissions, which pose a much greater risk to most artefact types (Thickett *et al.* 1998). The MDF baseboards were replaced with perforated inert Perspex boards.

Several of the adhesive joins had failed. The original adhesive was almost certainly some form of animal glue and hence does not emit ethanoic acid. Several later repairs using different adhesives were observed and polyvinyl acetate, PVAc was suspected, which is a strong source of ethanoic acid (Down 1996). Small samples of the original adhesive and later additions were taken and analysed with infra-red spectroscopy. The original adhesive was confirmed as animal glue and PVAc was identified in two later additions as well as several non-ethanoic acid emitting adhesives. The two PVAc adhesives were removed physically, as they had already failed. Two years after the replacement of the MDF and removal of PVAc, no formation of ethanoate salts on the previously affected shells has been observed under microscopic examination.

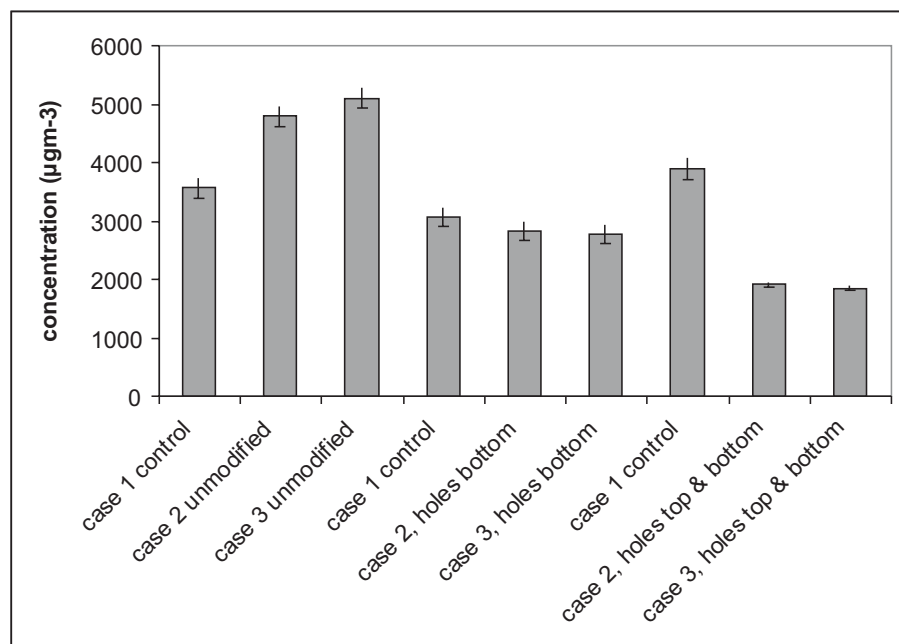
The following August, white corrosion crystals were observed on the solder of jet jewellery. The corrosion was identified as lead methanoate with X-ray diffraction and the jewellery had to be removed from the cases. Carboxylic acid analyses within the cases with diffusion tubes indicated concentrations of methanoic acid of between 3000 and 6000 $\mu\text{g m}^{-3}$, see Figure 8. The lead methanoate corrosion and high methanoic acid concentrations are characteristic of emission from paints. The paint was known to be from the Dulux range, but the exact identity had not been recorded. Analysis with colorimetry and infra-red spectroscopy indicated that it was an eggshell paint and likely to be 1060-Y. This paint had undergone extensive tests previously at the British Museum after a very similar problem. It did produce high concentrations of methanoic acid and lead methanoate corrosion. Tests to assess any drop off in corrosivity with time had unfortunately shown that even after three years it remained highly corrosive.

Figure 8. Carboxylic acids in painted case

Three approaches were tried to mitigate the paint's effect inside the cases. The air exchange rate was increased to reduce the concentration of methanoic acid in the air. A series of holes were drilled into top and bottom panels of the case doors to take advantage of the stack effect to maximise air exchange (Michalski 1994). The methanoic acid concentrations were reduced to below 3000 $\mu\text{g m}^{-3}$ (see Figure 8), however these concentrations still pose a very high risk of corrosion (Tetrault 1999). Trials were then undertaken to remove the paint. Hot stripping was found to be ineffective. Although dichloromethane

New close fitting MDF boards were constructed to fit the back, sides, top and bottom of the case and block the emissions from the paint. The boards were sealed with Moistop 622 and 3M 425 and then fabric wrapped. After fitting the boards, diffusion tube measurements could not detect methanoic or ethanoic acid in the showcase environment. The detection limits of those measurements were 42 and 70 µgm⁻³, well below the lowest reported threshold for lead corrosion (Tetrault 1999).
