## THE ARTIFACT, ITS CONTEXT AND THEIR NARRATIVE: MULTIDISCIPLINARY CONSERVATION IN HISTORIC HOUSE MUSEUMS

JW Evans is the most complete and untouched example of a Victorian silverware manufactory in the Birmingham Jewellery Quarter, England. This paper describes the process of developing a conservation philosophy of minimal intervention and the challenges of implementing such a policy whilst still protecting the 'spirit of the place'.

## Glitter and Gunge. Preserving the Future of JW Evans

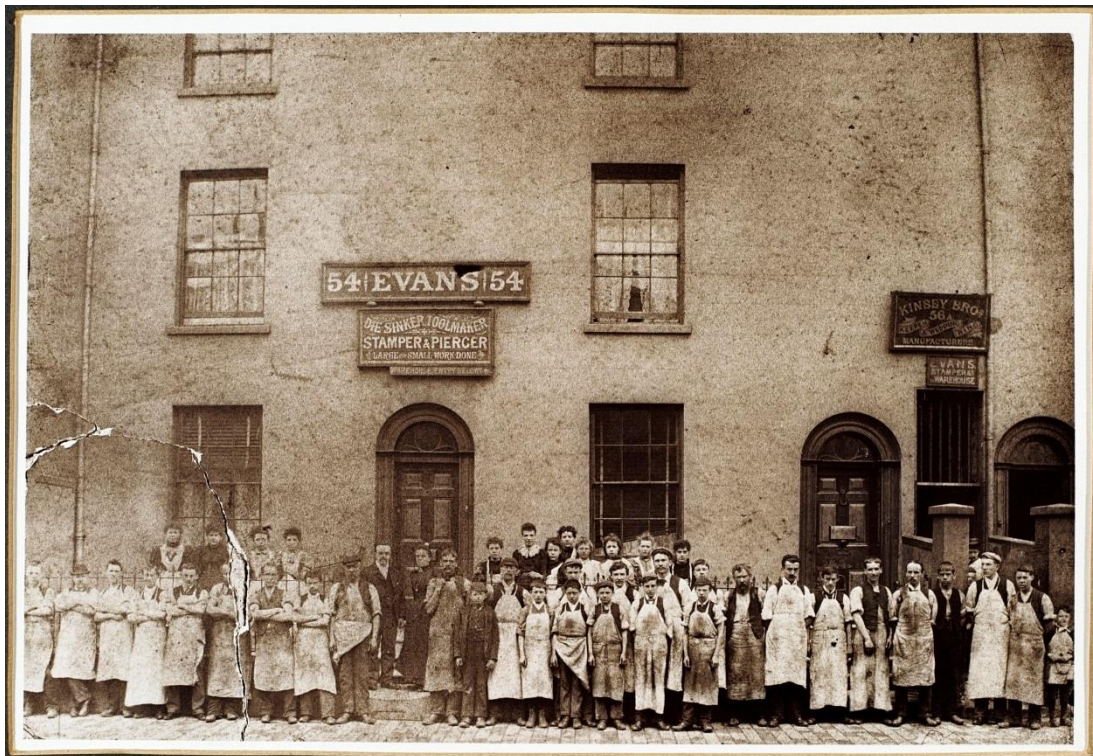
Fig. 2. Exterior JW Evans, c.1890. © English Heritage

The history of the site is well documented, with numbers 54-57 Albion Street built in 1836 as residential terraced houses with open yards or gardens behind. By the 1870's the gardens had been built over to provide workshops for manufacturing (a pattern typical of much of the Jewellery Quarter) [Demidowicz, 2010]. In 1881 Jenkin Evans began trading in 54 Albion Street and by 1901 he had demonstrated his talents as a business man; purchasing all four buildings and buying out his partners. The business passed to his son and finally grandson, Tony Evans, who was involved from 1955 until its sale in 2008. The continuous family association and a self-confessed hoarding mentality

prevented ‘cherry picking’ of useful items and the dispersal of tools and archives over the years (Figure 2).

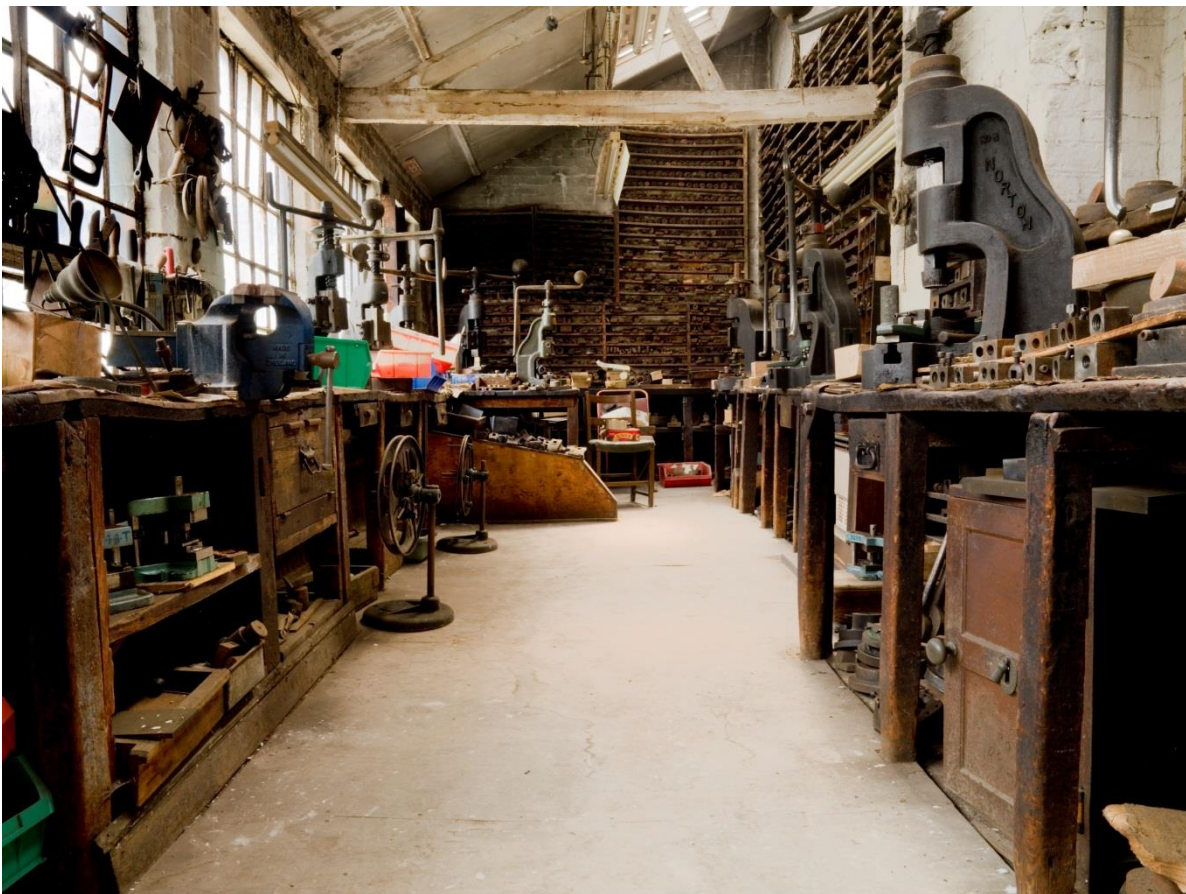
Fig. 3. Main Stamp Shop, 2008. © English Heritage

The purchase was completed in March 2008 but works did not begin immediately. There was an awareness of the delicate balance required to preserve the atmosphere of the property without losing significant information due to a lack of understanding of the processes. The rooms often showed evidence of their original use as residential spaces, before being subsumed for industry and the subsequent slide into neglect and disuse when they were no longer required during the later years of the less prosperous business. The amount of ‘dirt’ or dust on the tools often indicated their purpose and the frequency of their usage and the contents were significant because they were complete and in context (and in some cases had been so for over 50 years). It was these associations and wealth of inter-related information that could so easily have been lost by a simple inventory and ‘tidying up’ without a full understanding of the property (Figure 3).

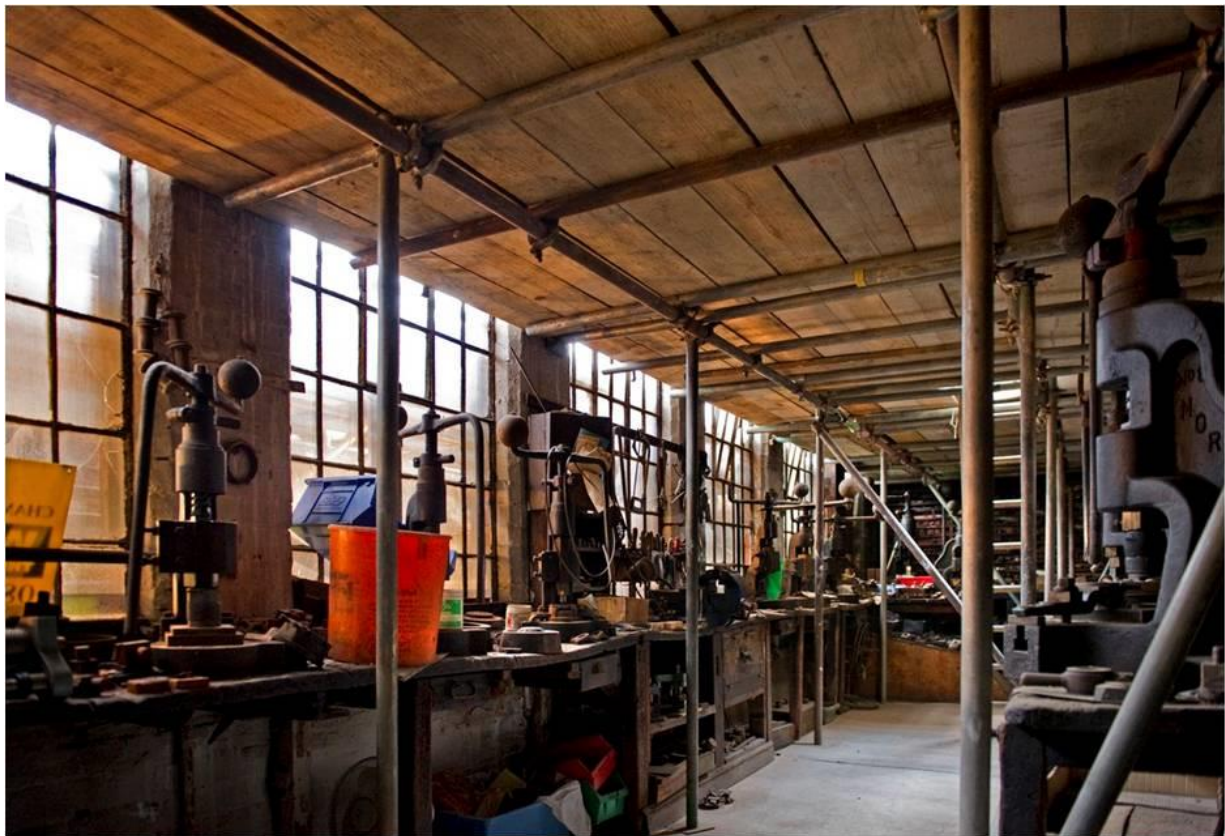
Fig. 4. In situ protection. © English Heritage

A system of protection criteria was specified and this key was then applied to different areas, for instance protection for stairs and hand rails would be Type G (Table 2). An unusual part of this strategy was to install scaffolding platforms throughout each of the single storey workshops (where the roofs were to be renewed) without first protecting individual items. These access platforms would also be used as false ceilings, protecting the contents underneath from dust, debris or possible Asbestos contamination (as well as contractors!). The scaffold planks were then lined with several thicknesses of polythene and sealed around the edges with pipe lagging. Any items projecting above this level were individually covered over and also tightly sealed. Some individual items underneath the platforms also had further protection, such as soft wrapping with Tyvek® or rigid boxes (some with viewing and ventilation panels) which were built to be sturdy enough to be stood upon (Figure 4).

their contents. There was a concern that the more common method of protection by ‘boxing in’ all the ferrous items and wooden shelving might cause an adverse microclimate in what was a very damp space, accelerating mould and corrosion damage. If the items were concealed, monitoring their presence (for security) or further deterioration would present problems. It was also acknowledged that it would be very hard to allow public access and engagement if everything was hidden for over a year. After much discussion and with the knowledge there would be an English Heritage conservator seconded to the project and on site throughout, an alternative strategy was developed for each room by the conservator and architect.

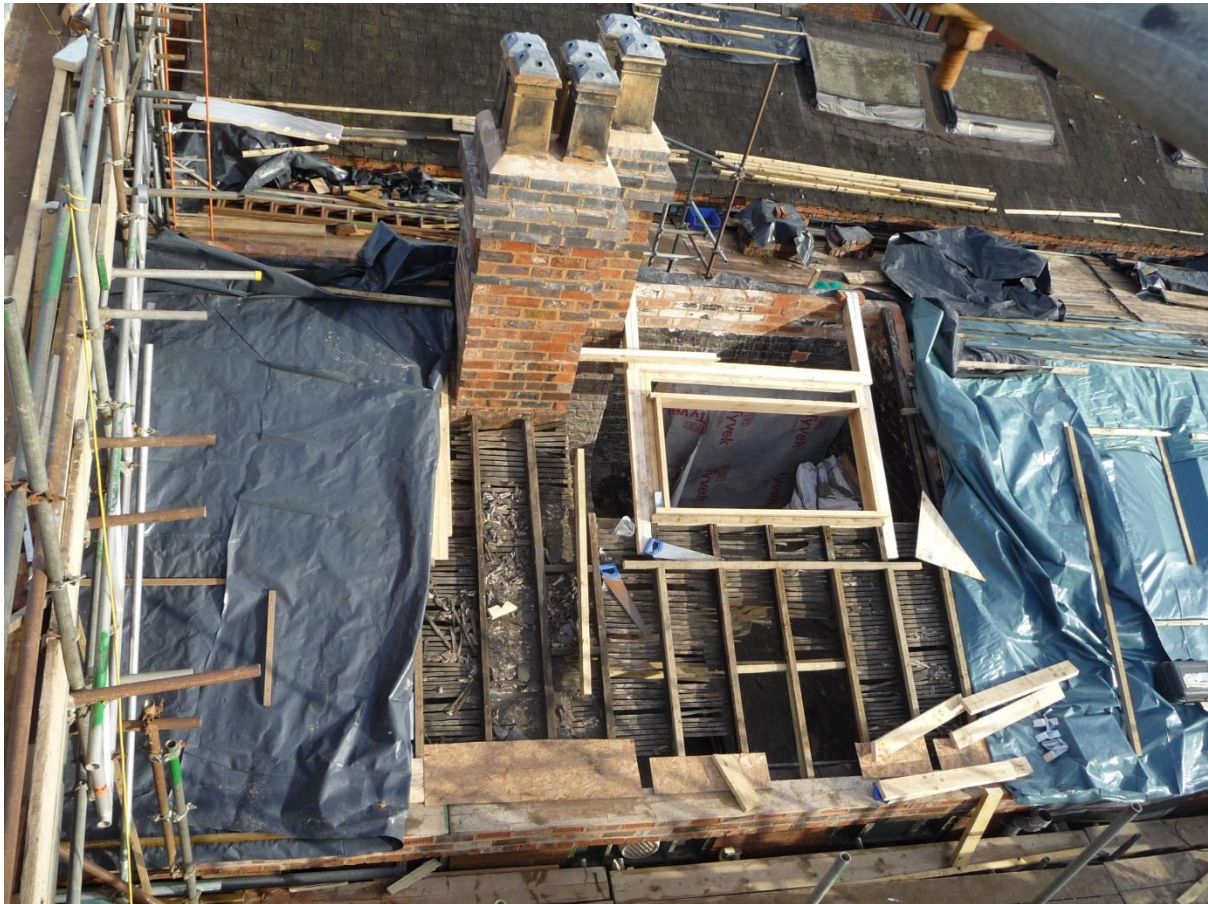
*Fig. 5. External works over protected rooms © English Heritage*

The scaffolding strategy proved to be justified. As the roofs began to be stripped and worked upon, it became clear that the plaster and lathe ceilings were in worse condition than the survey had indicated. Large parts of the ceilings were loose and some fell down as works began, but the scaffolding stood up well to these surprises and kept the spaces below clean and accessible. A great deal of supervision was required during installation due to the spaces being very narrow, difficult to negotiate with long poles and crowded with objects (not to mention dealing with the machismo attitude of the scaffolders). However, once in place, the platforms allowed the contractors to work freely above the rooms without being in contact with any contents (Figure 5).

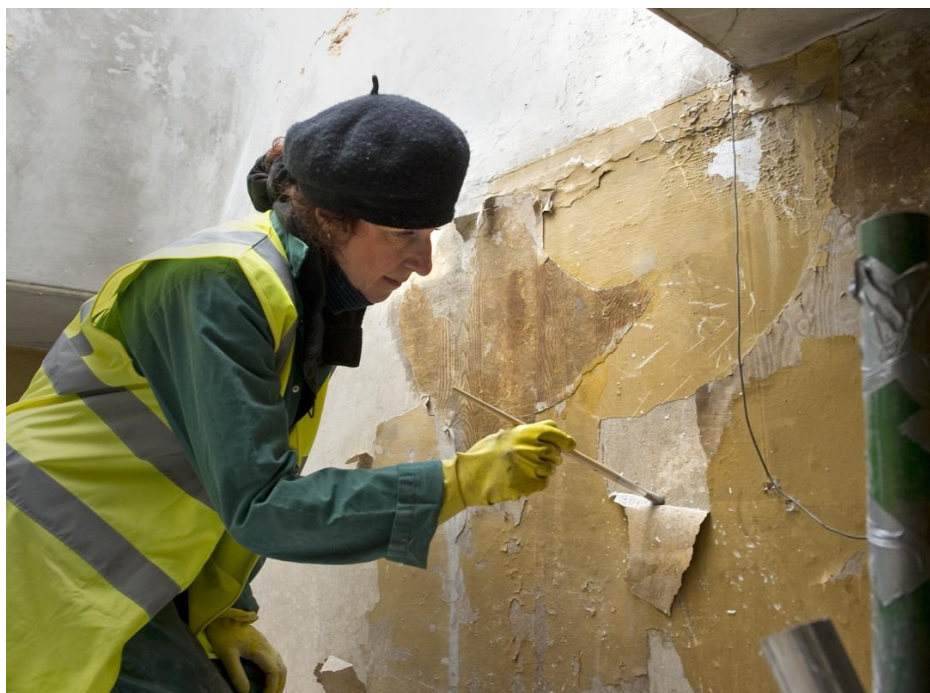
Fig. 6. Consolidation of interior surfaces. © English Heritage

Consolidation (but no redecoration) of the most deteriorated surfaces was carried out, both to slow deterioration and to make maintenance of the building and machinery practical. Vulnerable plaster edges were reinforced with a new plaster edging applied to prevent further crumbling filleted, flaking paint and plaster surfaces consolidated and peeling wallpaper was re-adhered to give greater strength (Figure 6). However a pragmatic approach had to be adopted due to the number and scale of the deteriorated surfaces. In very friable areas the loosest areas were gently brushed down, before the remaining area was consolidated. There was a programme of dust removal in certain areas, for instance in corners where the dust sealing failed and white plaster dust had fallen onto a cluster of objects. As ever this was not as straight forward as it might have been, with comic discussions of what was new and what was ‘historic’ dust, before a light hand with a pony hair brush and vacuum cleaner was employed.
