# The West Pier, Brighton

## Disrepair and destruction

**The loss of this Grade I pier highlights the importance of a national strategy for buildings at risk.**

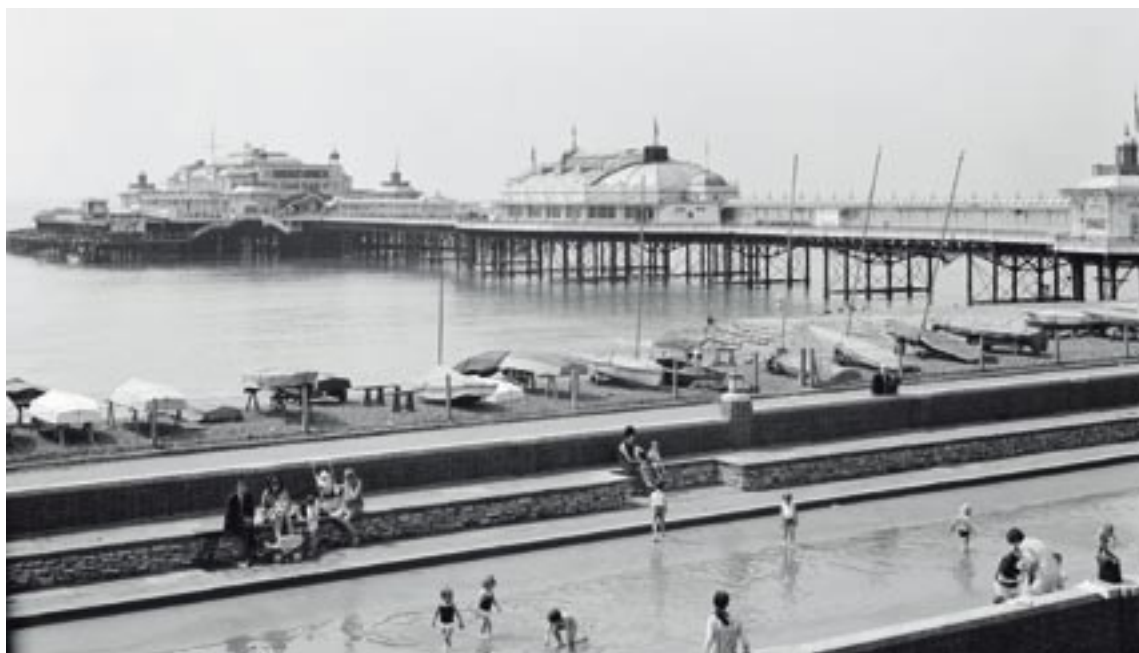
NMR BB70/06018 © Crown copyright/NMR

The West Pier, Brighton (Grade I), built in the mid 1860s, shown here in May 1970, with its historic promenade and pavilion.

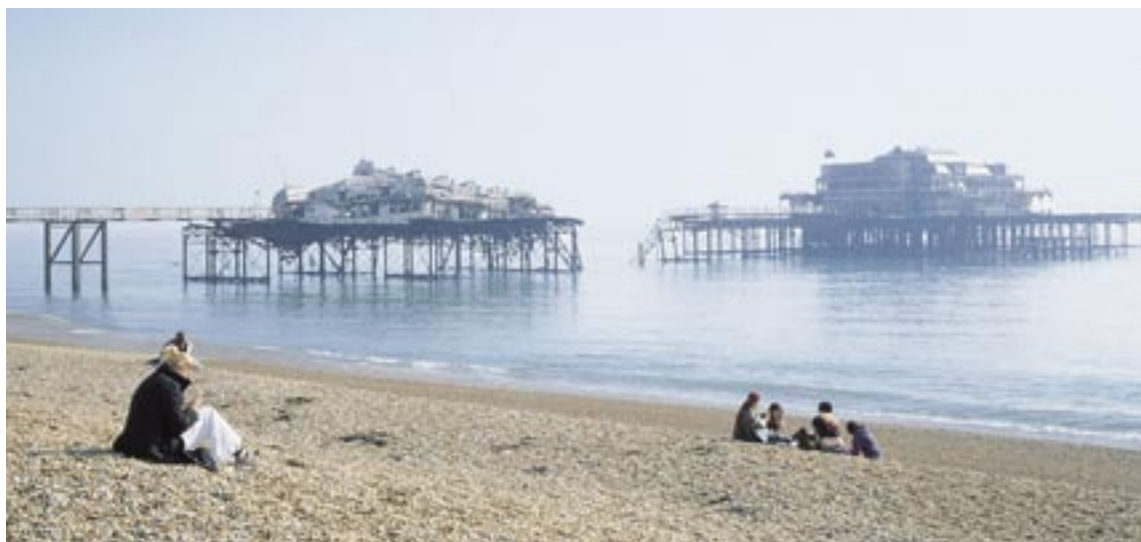
(above) © English Heritage Photo Library / Nigel Corrie; (below) NMR 23448 / 20 taken 31 March 2004 © English Heritage NMR

The decline of the West Pier: March 2003, after the final storm of the New Year (above), and March 2004, after fires at the concert hall in March 2003 and the pavilion in May 2003 (below).

Unfortunately, in any repair case, there is a point where the escalating cost meets the reducing amount of historic fabric, and this point was eventually reached during the storms of 2002–3.
