SILBURY HILL CONSERVATION PROJECT

Update 32: progress for 5th April – 25th April 08

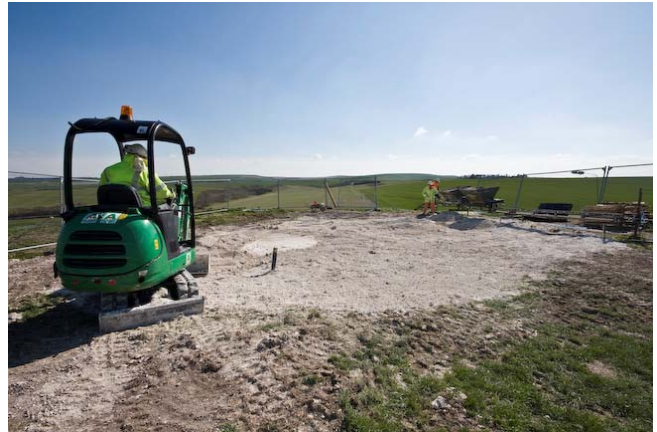
All of the conservation work on the hill itself has now been completed by Skanska. This includes the filling of the crater on the summit which had previously opened up back in 2000, when the 1776 shaft opened up on the top of the hill. The infilling involved delivering a total of 580 tonnes of chalk to the summit, 497 tonnes of which was pumped up in the form of a chalk paste, as discussed in previous updates. This paste fill has subsequently been capped with crushed chalk (figure 1) which was hauled to the top of the hill using the monorail and winch system.

Figure 1: completing the hilltop works

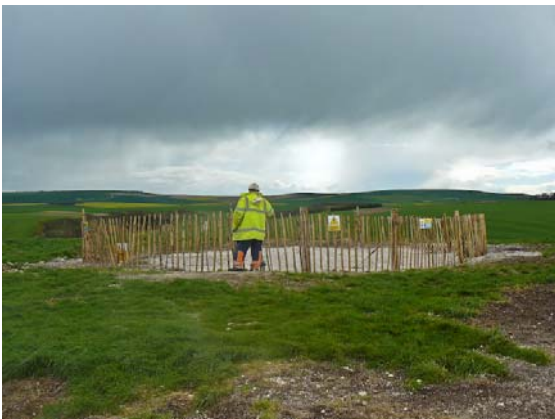
Figure 2: The finished hilltop works

A temporary chestnut paling has subsequently been installed around the fill area (figure 2) to ensure that this is allowed to completely dry out safely. Once it has done so it will then be removed.

Bare patches to this area and the summit fill will be seeded with an appropriate seed mix before leaving site.

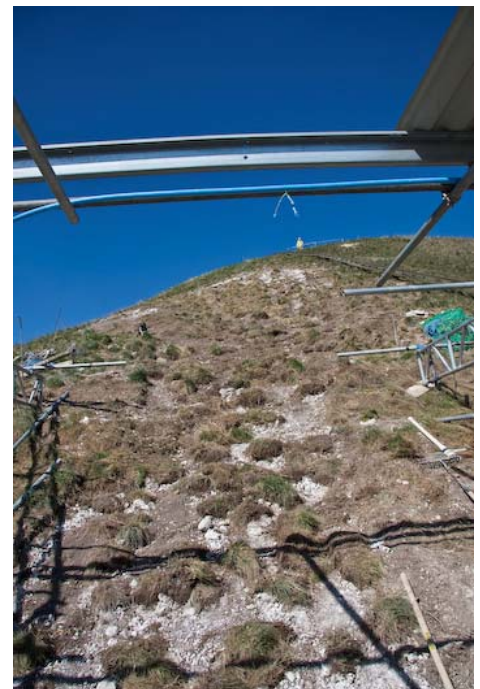
Work has also been completed to backfill the depressions on the south slope of the hill above the entrances to the Merewether and Atkinson tunnels (figure 3). Here the turf that was retained has been reinstated on the chalk infill.

Figure 3: The completed hillside works
