# Investigating Wall Paintings

## Seeing is believing

Robert Gowing Senior Wall Painting Conservator, Building Conservation Research Team

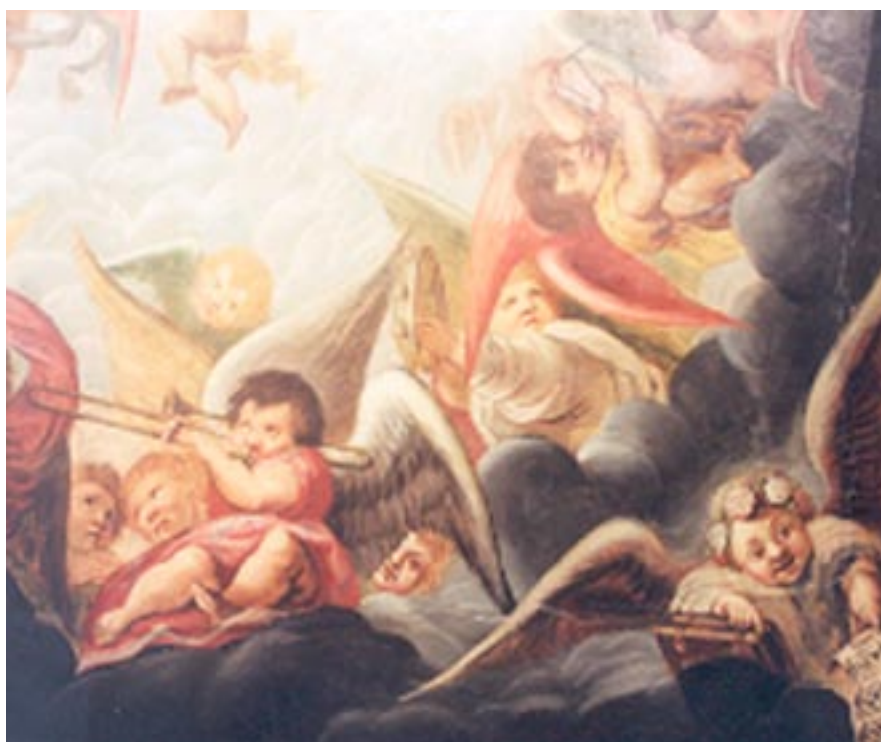
The ceiling of the Heaven Room in Bolsover Castle, Derbyshire, with an allegorical painting of the early 17th century. It was suggested that the painting had been extensively over-painted: this was not clear under visible light because of the application of a modern varnish.

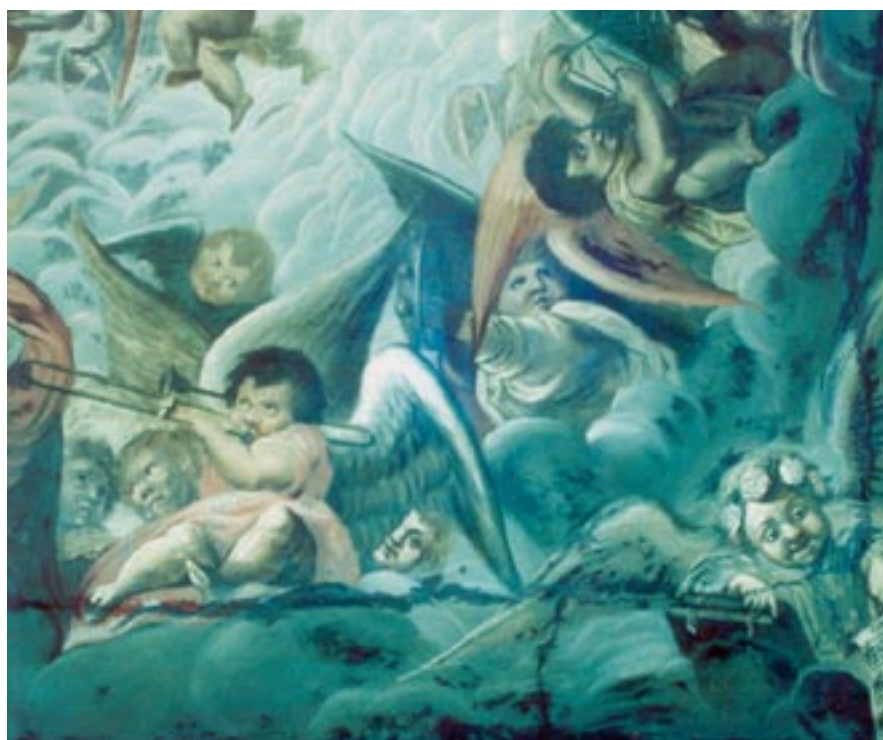
The same area recorded under UV illumination clearly shows that re-touching was limited to localised losses and damage (areas appearing darker), while the majority of the ceiling is original. This UV survey was able to reduce the need for sampling of the painting.

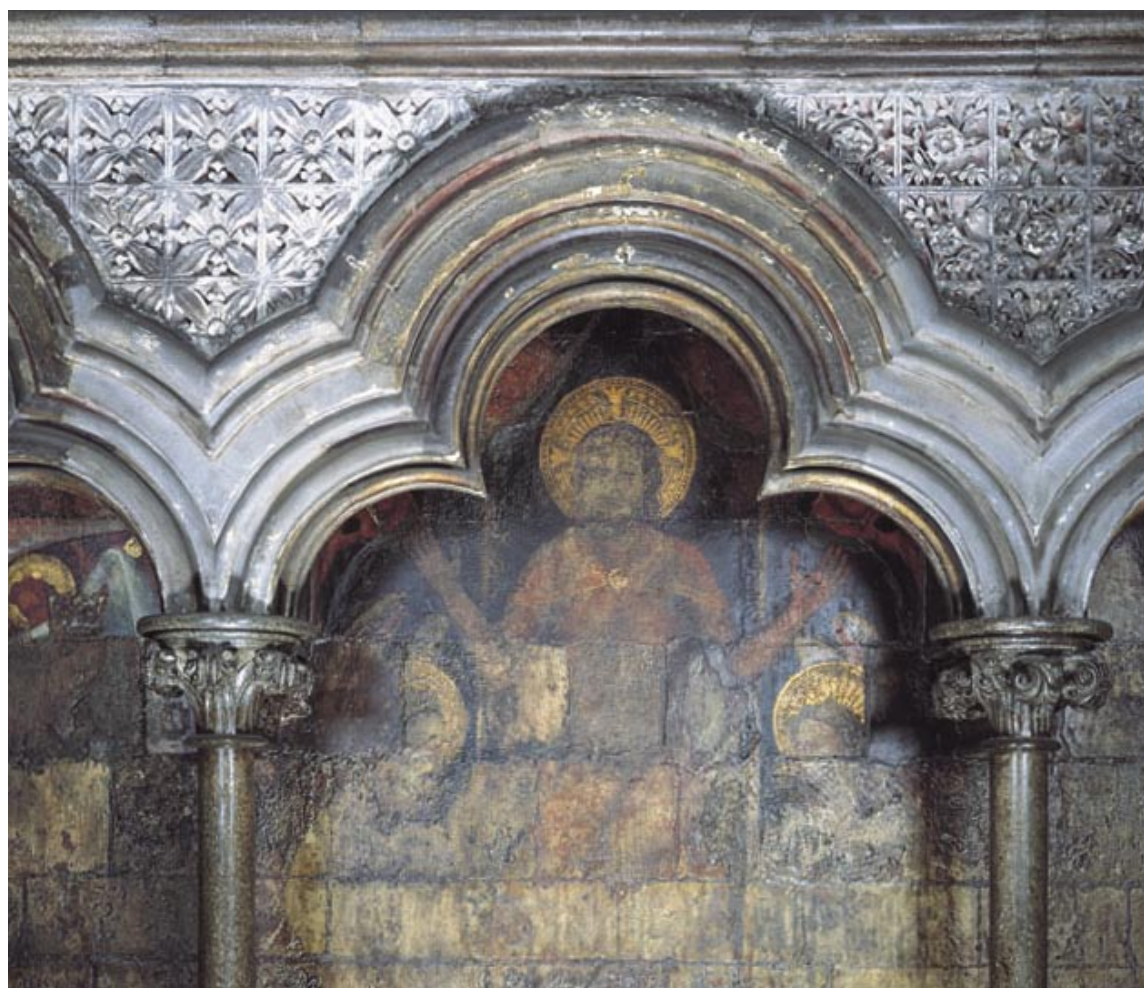
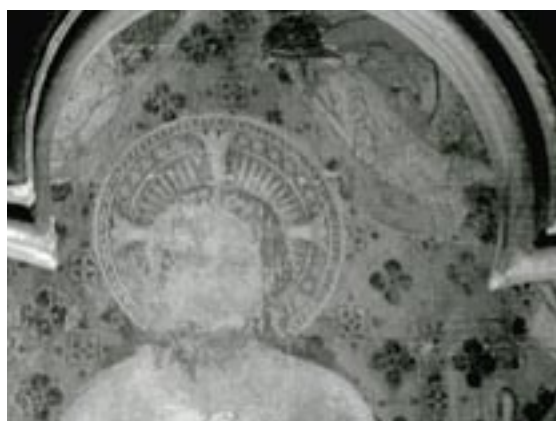
In visible light, the drapery behind Christ in this late 14th-century wall painting in the Chapter House, Westminster Abbey (*above*), appears undecorated. When recorded in the near-IR region, a floral brocade pattern emerged, with under-drawings, which guided later sampling.

**IR REFLECTANCE:** Its longer wavelength means that IR radiation can penetrate quite deeply into the surface of the painting, being reflected back to the eye only when it meets a dense material. Charcoal being one such material, IR reflectance has had some value in revealing carbon black underdrawings for wall paintings.

In the 1960s, IR reflectography was developed to look at IR emissions beyond the film sensitivity range, and there are now a number of relatively portable systems that can capture defined wavebands up to the far IR (between 900 and 2500 nm). Interestingly, the charge coupled device (CCD) inside many digital cameras is now sensitive to IR in regions up to almost 1200 nm. With their factory-installed IR filters removed, these can provide a useful low-cost alternative, or perhaps a quick test to see whether more elaborate systems are likely to prove useful.
