Stone Consolidants

Inorganic treatments

John Fidler *Conservation Director*

New research on inorganic solvents offers improved techniques for masonry conservation.

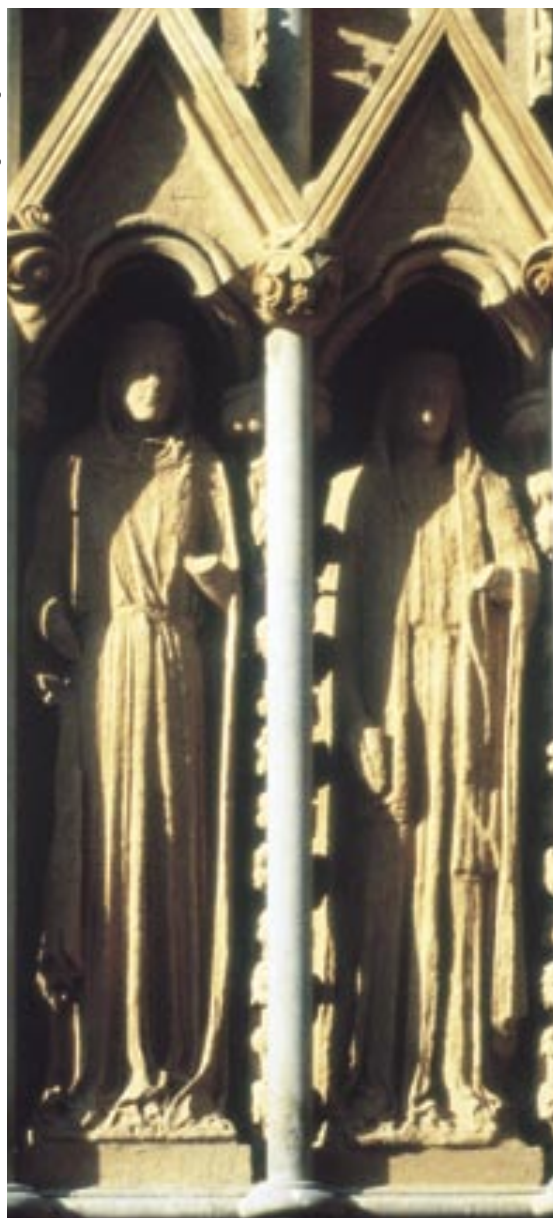
Wells Cathedral, Somerset, where extensive consolidation with calcium hydroxide has been carried out.

In England, we have a long track record of experimentation with so-called ‘preservatives’. William Lethaby, for example, cited the medieval practice of using linseed oil to protect stonework, and Professor Robert Baker revived limewatering and lime shelter coats at Wells Cathedral (Fidler 2002). After the fiasco of the serious stone decay of A W N Pugin’s facades at the Palace of Westminster within 30 years of building, the report of the public inquiry in 1861 included investigations of solutions such as Sylvester’s treatment (1846), a water repellent based on soap and alum. Most of the consolidating materials used unsuccessfully in the second half of the 19th century included potassium or, even worse, sodium silicate (‘waterglass’) such as Kuhlmann’s patent of 1852 and Szerelmey’s of 1857.

Ways have been found to remedy some effects in traditional practice. For example, in the application of lime watering (using calcium hydroxide), the amount of material in solution can be increased by increasing the use of sugars, by limiting sedimentation with ethanol or by using dispersed lime (micro-particles). Also, for statuary, a new approach is to apply the solution in a 100% carbon dioxide environment.

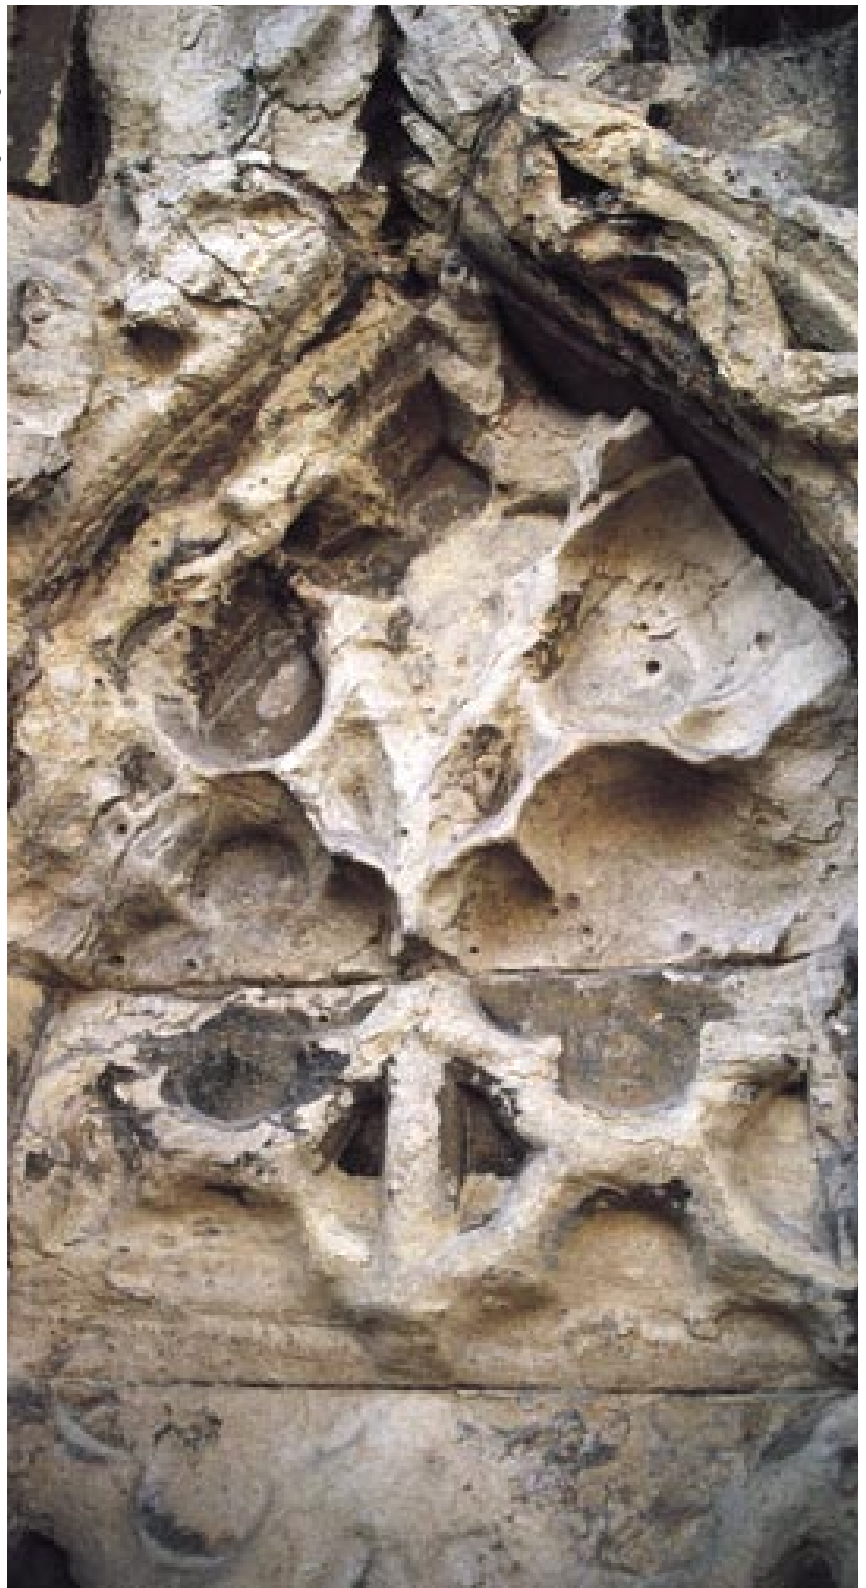
Howden Minster, Goole, North Humberside. Deterioration of decorative tracery in an external arcade built of magnesium limestone, which is particularly difficult to consolidate.
