CHISWICK HOUSE AND GARDENS REGENERATION PROJECT – ARCHAEOLOGICAL EXCAVATION

Update 1: progress for 25 March – 11 April 2008

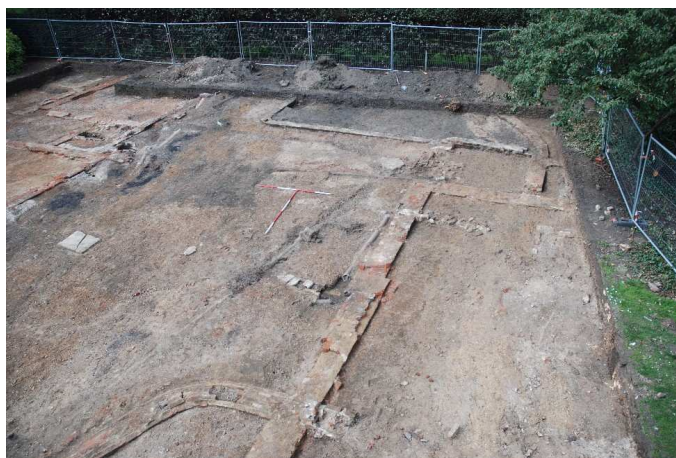
View of the northern half of the main trench showing the walls of the 17th century Service Building (top left of photo) with walls of adjacent buildings, garden walls and drainage features evident in the rest of the trench.

The main excavation trench covers the proposed café footprint (measuring 29x25m), and is located over the eastern range of the 17th-century Service Building that was formerly connected to the Jacobean House to the west. Even at such an early stage in the project this trench has proved to be extremely interesting, with a large number of walls and drainage features exposed, as can be seen on the photograph below. Several distinct phases of development of the Service Building can already be established although more excavation work is required over the next 3 weeks to record the sequence of construction and later modifications to the building.
