RICHBOROUGH EXCAVATION 2008

Update 1: progress for 1-14 September 2008

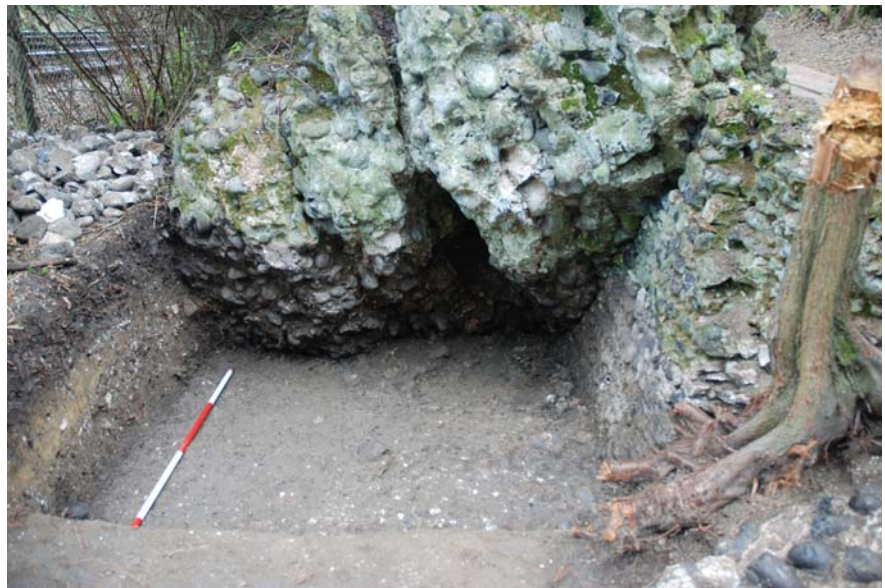
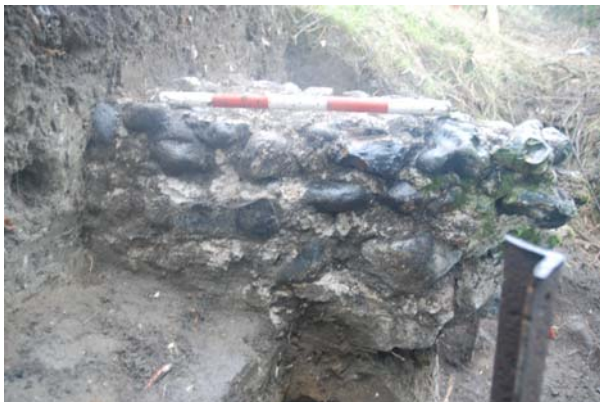
Trench 2 was planned to examine an apparent piece of Roman standing wall between two blocks of the collapsed east wall of the fort. We thought that the collapsed east wall of the fort had come down on it and broken it. Instead this wall has proved to be medieval and survives to a height of at least 2m. It seems to be built to utilise the fallen wall as a riverside frontage. A complete, long, clay pipe found pushed under the fallen wall at a much later date seems to be contemporary with the building of the adjacent railway, probably deposited by a navy taking shelter by the wall!

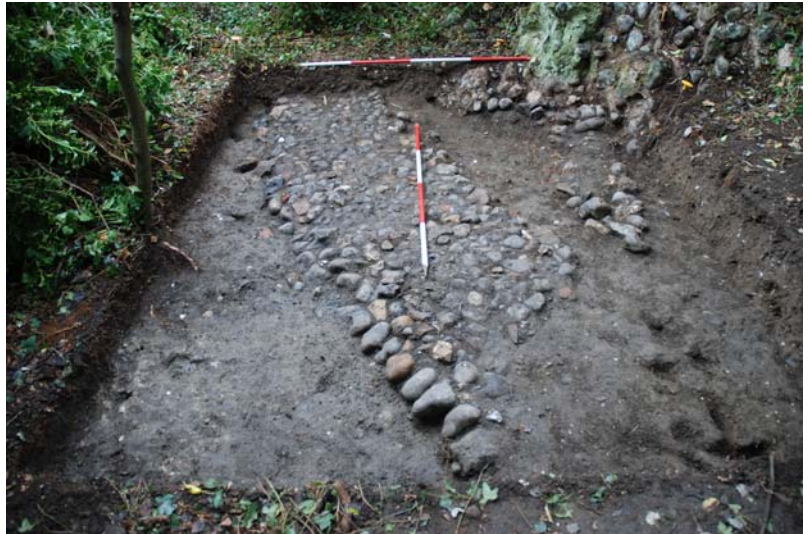
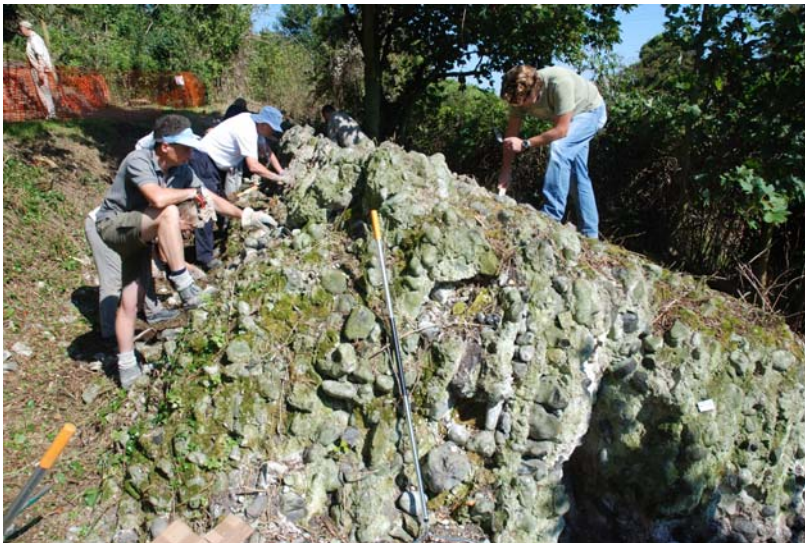
Trench 4 has so far revealed a post-medieval pathway. This sits on a thick layer of hill-wash.

Cleaning of the collapsed wall of the Saxon Shore fort has revealed several important details of its construction and facing. There is certainly an element of in-situ Roman building upon which the wall has collapsed. This remains to be examined.
