SILBURY HILL CONSERVATION PROJECT

Update 27: progress for 21st Dec 07 – 10th Jan 08

Engineering Update

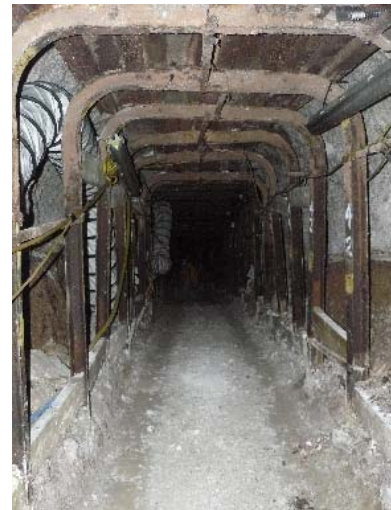
The condition of the central tunnels remained unchanged over the Christmas period, with no signs of deterioration or ground movement. The mechanical infilling already emplaced has consolidated extremely well with no evidence of settlement or loss of compaction, providing re-assurance that the infill will perform as designed over the long term to prevent any settlement or movement within the hill.

Figure 1: Tunnel conditions 7th Jan 08

The project closed down over the Christmas period from 21st December 07. Works have now re-commenced to complete the mechanical infilling of the central tunnels and to install the pipes and walls required to allow the filling of the remainder of the tunnels.

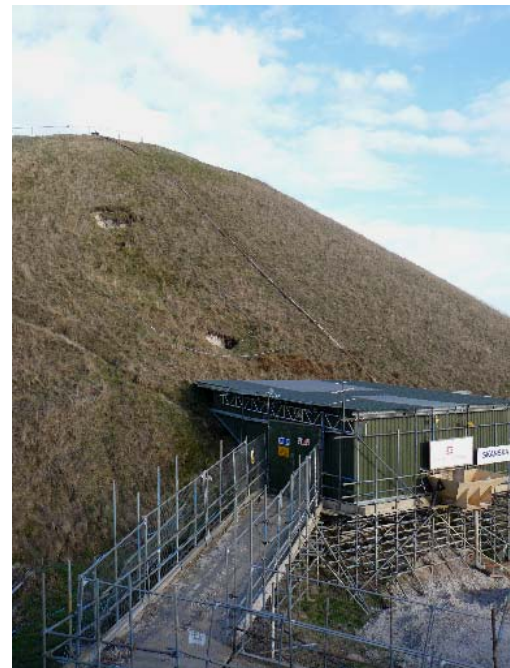
On the evening of Thursday 3rd January/early Friday 4th January 2008, following extremely heavy rain, three small areas of collapse, some 1 to 1.5m deep each, appeared on the south side of the hill. These areas were all previously visible as depressions in the hillside and are directly linked to earlier collapses over the outer sections of the Merewether and Atkinson tunnels.

The upper two areas of collapse were into previously detected voids above the re-excavated Atkinson tunnel. The lower of the three collapses led to a breaking through of material into the re-excavated tunnel itself. This material has now been cleared by Skanska and mechanical backfilling operations at the centre of the hill have recommenced.

Figure 2: hill side collapse features

The newly exposed sides to the areas of collapse will be archaeologically recorded prior to being backfilled with chalk as part of the current programme of conservation works. This backfilling will be undertaken once the tunnel beneath has itself been filled.
